# ASSEMBLY INSTRUCTIONS FOR TENSIONING PULLEY 55443 IN TOOTHED BELT KIT 5544370 AND WATER PUMP KITS 55443701 AND 55443702

TECHNICAL INFO NO. 1059

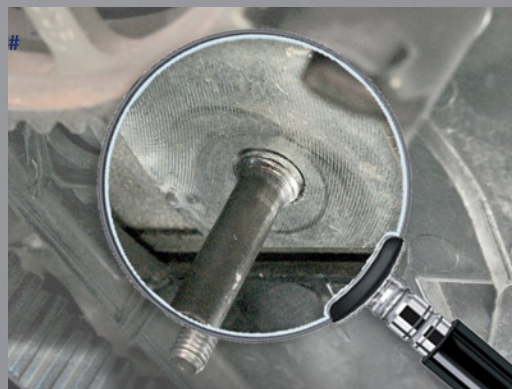
1. The stud is not correctly screwed in.

If the thread (M10) on the stud is not completely screwed in (see Image 1), the tensioning pulley does not lie flush with the surface of the engine block and will therefore become damaged. Tightening the tensioner onto the protruding threaded portion of the stud will give the impression that the tensioner is correctly clamped.

When the engine is running, the resulting forces in the tensioning pulley may cause the stud/tensioner to come loose, which could lead to major engine damage.

When installing tensioning pulley 55443, you must ensure that the thread (M10) on the stud is fully screwed into and flush with the engine block. The thread must not protrude from the block (see Image 2).

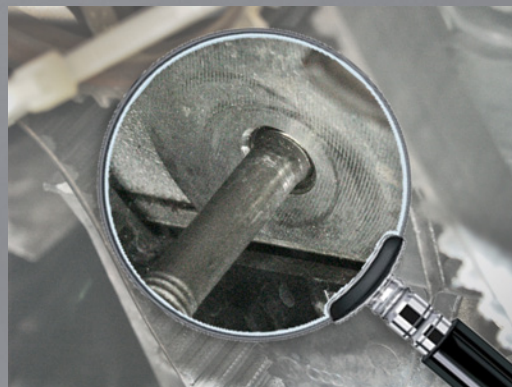
2. The stud is correctly screwed in.
